MDP Sec #1

Location	Main electrical
Equipment	MDP Sec #1
Additional information	Feeds Panel 'C'
Date	2/25/2009
Time	9:30:33 AM

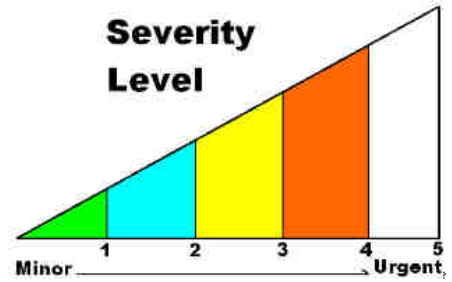
Fault	Heat
Fault Temperature	123.0°F
Reference Temp	79.5°F
Difference	43.5°F

Bus connection is loose. Requires outage to repair.

Repair
